## PROBLEMS OF VARISTOR QUALITY ASSESSMENT DURING EXPLOITATION

### Abstract

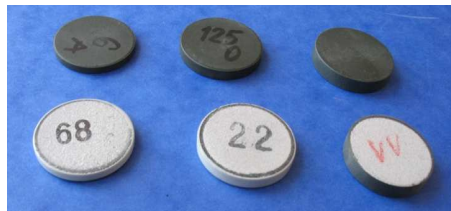
Fig. 1. Varistor samples: ZnO structures after being fired (top row) and with metalized contacts (bottom row); the thickness of the varistor structure determines the voltage value when the varistor begins to conduct current: left – 280 V, middle – 440 V, right – 660 V.

Varistors are produced on the basis of zinc oxide (ZnO) with a homogeneous distribution of various dopants – other metal oxides (e.g.: bismuth, cobalt, manganese) – in the ZnO mixed powder [1-4]. The composed material is usually cylindrically shaped in a press and fired later at high temperature (Fig. 1), to aggregate ZnO into grains. The aggregation process depends on how the used materials are mixed and squeezed. The mentioned additives play an important role during aggregation processes and are precisely selected by the varistor producer.

The voltage when varistor starts to conduct current is determined by the number of the grain junctions between the varistor electrodes. Thus, a shift in these voltage values is provided by changing the element thickness or applying a stack of the elements. The latter method is used for preparing varistors which protect high voltage power lines.

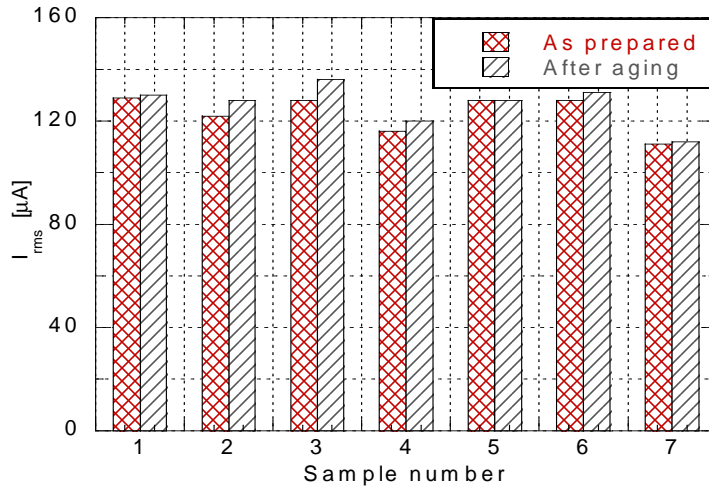
Fig. 6. Changes of the leakage current  $I_{rms}$  in an exemplary set of seven varistors at a polarizing voltage of 350 Vrms before and after aging by applying 1000 current pulses of amplitude 0,5 kA and duration 8/20  $\mu\text{s}$ .

The above-mentioned problems of varistor quality monitoring in their working mode suggest that the most reliable method should base on measurements of their leakage current and temperatures at excessive overvoltage pulses. There is clear evidence that even not too intensive aging by repeated current pulses increases slowly varistor leakage currents (Fig. 6).

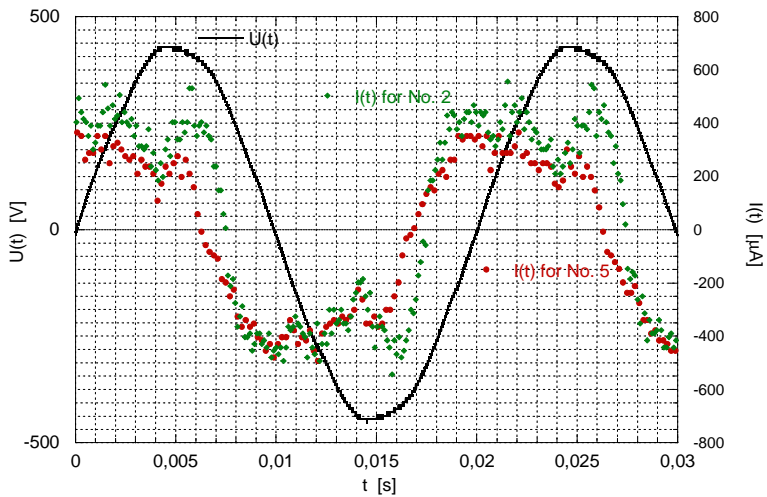
Fig. 7. Intensity of leakage current  $I(t)$  flowing through varistors of poor (No. 2) and high (No. 5) quality polarized by sinusoidal voltage  $U(t)$ ; the investigated varistor's working voltage  $U_{RMS} = 275 \text{ V}$ ; the current  $I(t)$  was measured by current transformer, model Kyoritsu KEW 2432.

The leakage current can be easily measured during overvoltage pulses by a cheap electronic unit, isolated from the power supply line circuit (Fig. 7). The more problematic are varistor temperature measurements because the temperature sensor has to be powered and placed close to the varistor structure. Otherwise, such placement increases the probability of moisture invasion into the grained structure.

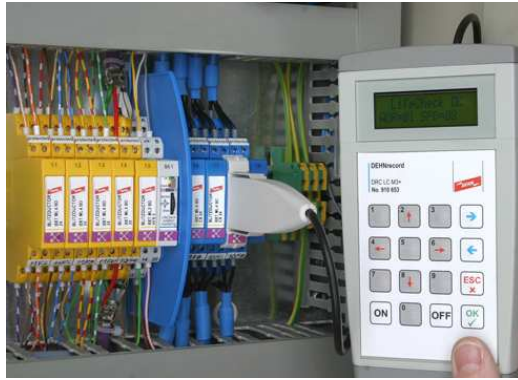
Fig. 8. Measurement system of varistor quality in a household power network proposed by DEHN [10].
